March 31, 2026

Re: Pre-Demolition Asbestos Inspection – Village of Oak Harbor Water Treatment Plant – Headworks & Trickle Pump Buildings

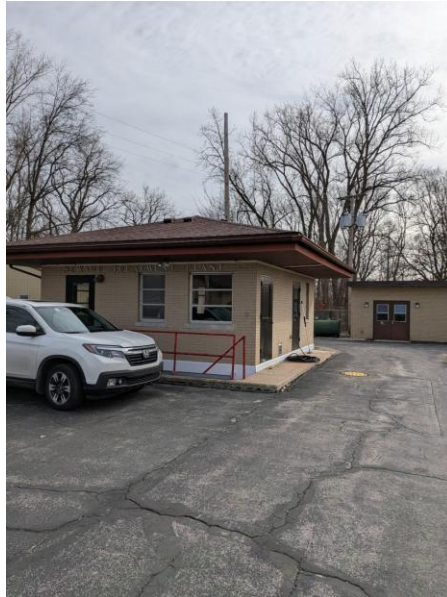
| Sample # | Sample Description | Layer | % Asbestos |
|---|---|---|---|
| 300-2 | Headworks Building, West Side/Window Glaze | Light Gray Brittle | 1.75% Chrysotile* |
| 300-3 | Headworks Building, East Side/Window Caulk | Brittle Tan | 2.5% Chrysotile* |
| 300-4 | Headworks Building, West Side/Window Caulk | Brittle Tan | 1.75% Chrysotile* |
| 300-5 | Headworks Building, East Side, Door/Window Glaze | Beige Brittle Painted Black | 0.75% Chrysotile* |
| 300-6 | Headworks Building, East Side, Door/Window Glaze | Beige Brittle Painted Black | 1.5% Chrysotile* |

**Headworks Building – glaze on windows and doors contains asbestos.**

| Material | Quantity | RACM (Friable) | Category I Non-Friable | Category II Non-Friable | Removal Required Prior to Renovation or Demolition? |
|---|---|---|---|---|---|
| Window glaze – doors and windows | 7 windows and two exterior doors | | | X | This material will become friable during the renovation process and must be removed prior to demolition of the building. Removal is considered Class II asbestos abatement under OSHA. |

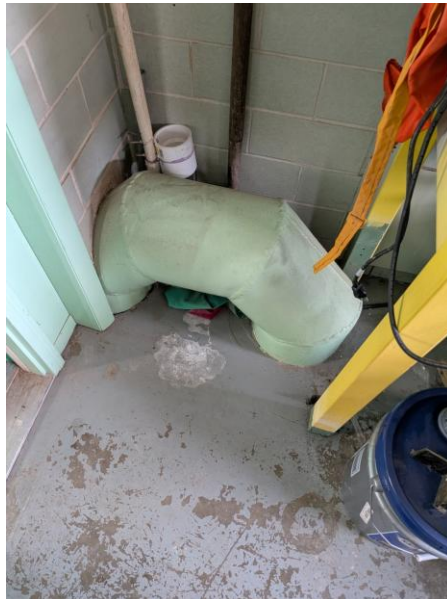
There are Asbestos Containing Transite pipes that are used to exhaust air on the two lower levels. It appears these pipes transition to metal once they are on the ground level floor of the building. There is vibration cloth connected to the Transite piping on the upper basement, this material was not tested as the exhaust was still in use on the day of the inspection; it is presumed to contain asbestos.

**Transite pipe transitions to steel at this point on ground floor.**

| Material | Quantity | RACM (Friable) | Category I Non-Friable | Category II Non-Friable | Removal Required Prior to Renovation or Demolition? |
|---|---|---|---|---|---|
| Transite Asbestos Piping (PACM) | ~ 45 linear feet of 2-foot diameter pipe | | | X | Removal is considered Class II asbestos abatement under OSHA. Transite materials will become friable if they are handled improperly. The Transite piping must be removed prior to demolition of the building. |

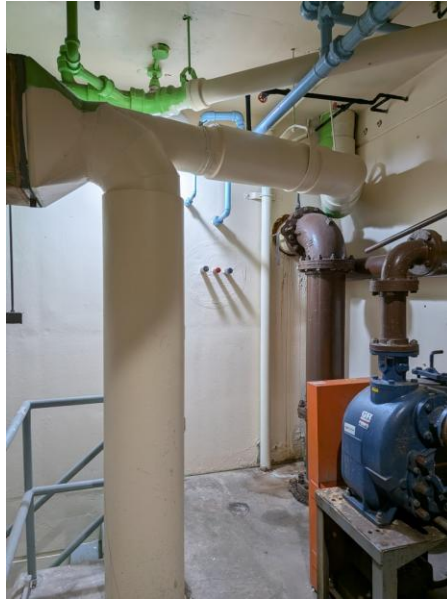
**Transite piping on 1<sup>st</sup> basement level.**

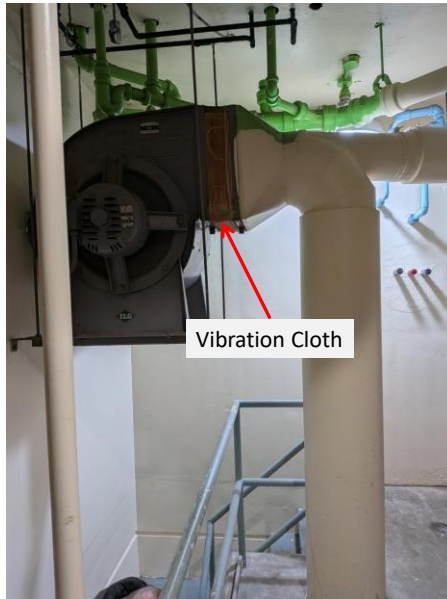
**Vibration Cloth**

**Transite pipe with PACM vibration cloth.**

| Material | Quantity | RACM (Friable) | Category I Non-Friable | Category II Non-Friable | Removal Required Prior to Renovation or Demolition? |
|---|---|---|---|---|---|
| Vibration Cloth (located in the first basement) (PACM) | Less than 2 square feet of vibration cloth installed adjacent to Transite pipe | | | X | This material is in good condition. However, it should be removed when the Transite pipe adjacent to it is removed and disposed.<br><br>Removal is considered Class II work under OSHA. |
