March 31, 2026

Re: Pre-Demolition Asbestos Inspection – Village of Oak Harbor Water Treatment Plant – Headworks & Trickle Pump Buildings

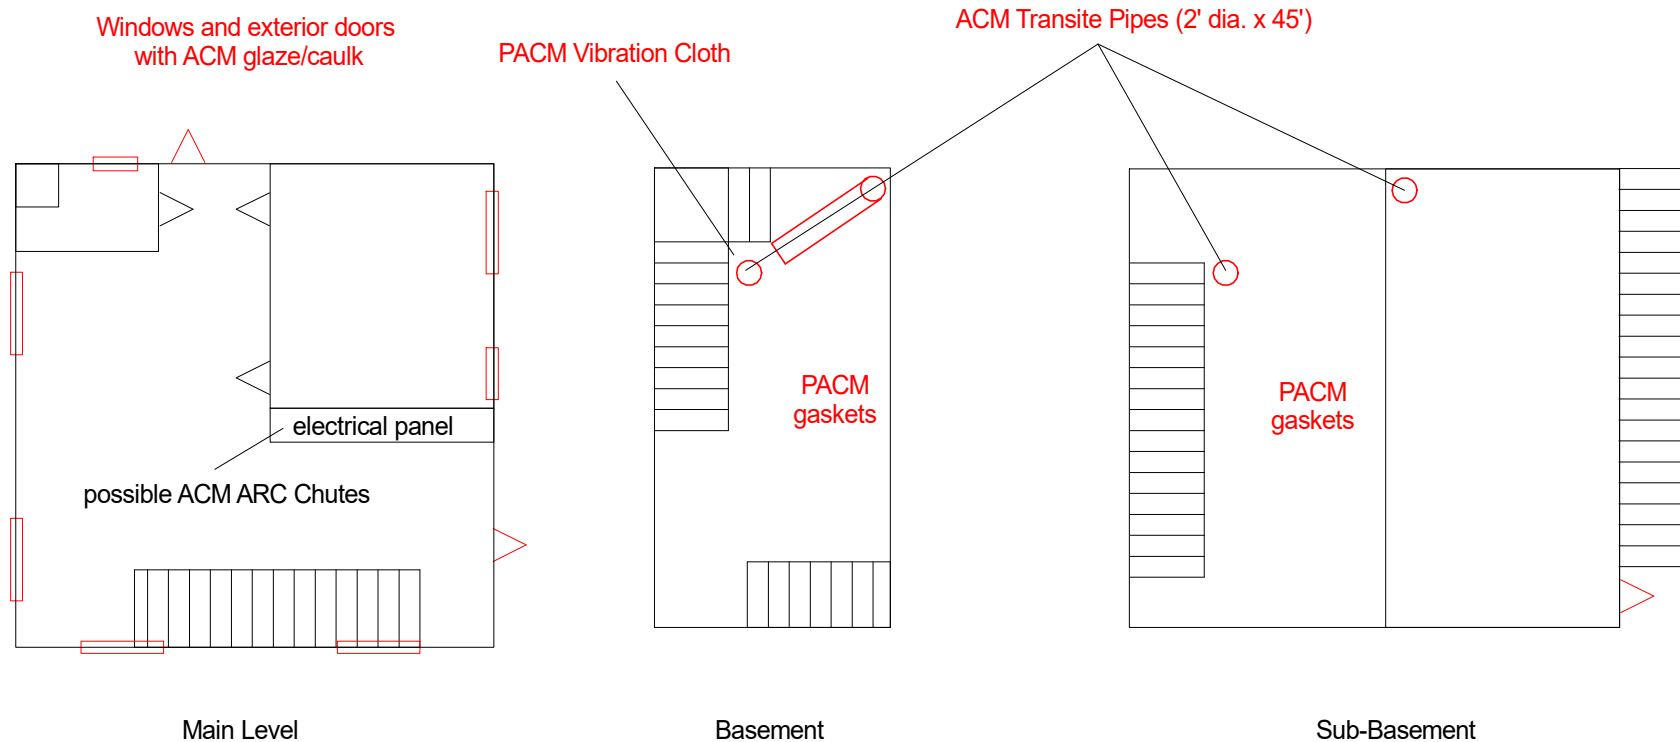
**Vibration Cloth**

| Material | Quantity | RACM (Friable) | Category I Non-Friable | Category II Non-Friable | Removal Required Prior to Renovation or Demolition? |
|---|---|---|---|---|---|
| Transite Asbestos Piping (PACM) | ~ 45 linear feet of 2-foot diameter pipe | | | X | Removal is considered Class II asbestos abatement under OSHA. Transite materials will become friable if they are handled improperly. The Transite piping must be removed prior to demolition of the building. |

**Transite pipe with PACM vibration cloth.**
